A Laboratory Study of the Stability of Sand-Filled Nylon Bag Breakwater Structures

by
Robert Ray

MISCELLANEOUS REPORT NO. 77-4
MARCH 1977

U.S. ARMY, CORPS OF ENGINEERS
COASTAL ENGINEERING
RESEARCH CENTER

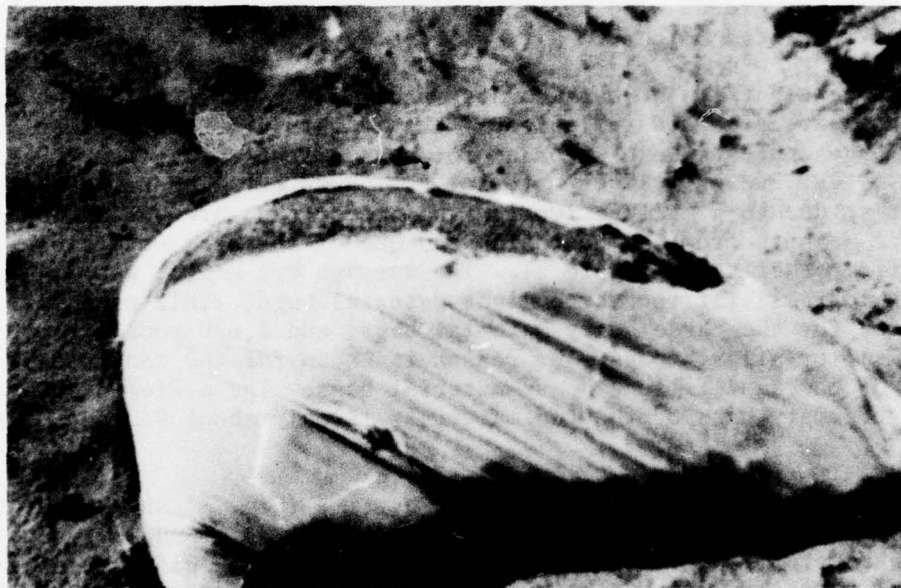
Uncoated or unprotected white nylon deteriorates under exposure to sunlight, specifically ultraviolet light. By the spring of 1967, several field installations of protective revetments had been built of bags and subjected to exposure damage. An estimate of the lifespan of nylon sandbags exposed to the weather (protected from vandalism and wave action) was needed for comparison with the performance of alternate construction materials. A single bag was filled with sand and left on a sandpile exposed to the weather from April 1967 to September 1968 (Fig. 1). Periodically, the bag was probed with the toe of a shoe to test the condition of the material. Between October 1967 and the end of the test, the bag split open along the length of the upper face, evidently due to photochemical (actinic) deterioration of the nylon filaments (Fig. 2).

Figure 2. Sandbag exposed to sunlight, September 1968.

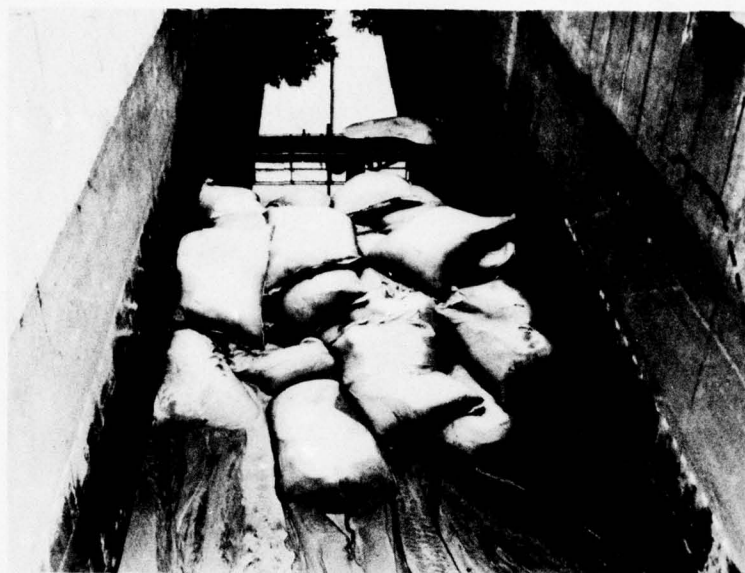
b. Midtest Tank Draining. Structure I was the only breakwater inspected during the progress of a test. Surveys during wave conditions a and b indicated that scour was occurring around the structure (Fig. 12). After 2 hours of condition b, the tank was drained for inspection. It was noted that the structure had partially trapped water on the back side and that water was leaking under and through the structure (Figs. 13, 14, and 15). Also, two bags on the bottom layer appeared to be partially emptied. The tank was refilled and wave condition b was continued for another 4 hours to determine if the scour would continue. Subsequent surveys indicated that scour had occurred at the leeward toe, and the breakwater, apparently undermined, had settled during this stage of draining and wave action. The profiles after the additional 4 hours were considered to be the adjusted initial profiles. After these difficulties, the tank was drained only between tests.

Figure 13. Front face after midtest tank draining (test I).

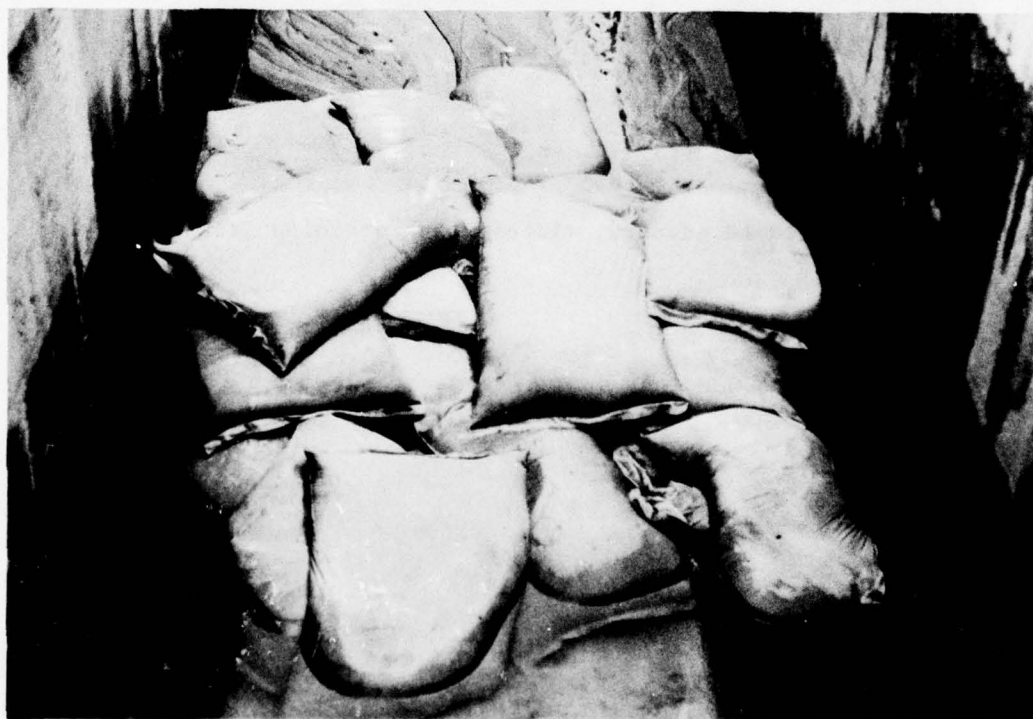
Figure 14. Backface after midtest tank draining (test I).

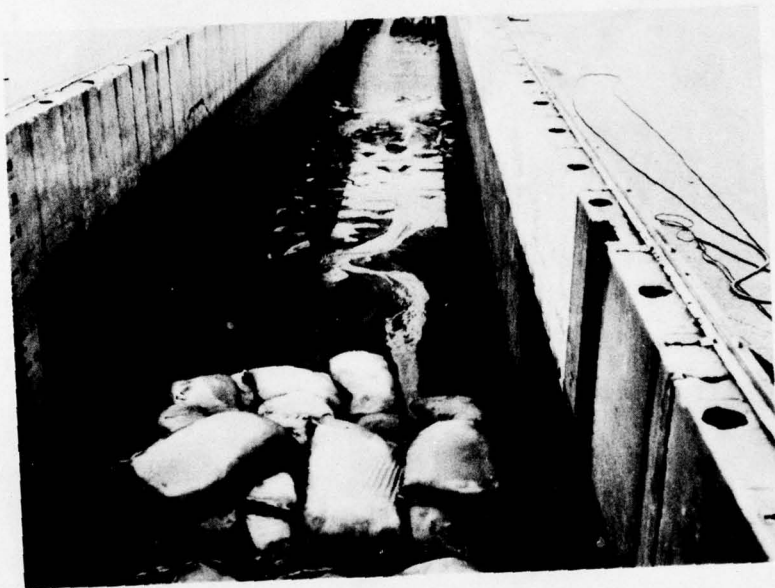
Figure 15. Sand bed to seaward, midtest tank draining (test 1).

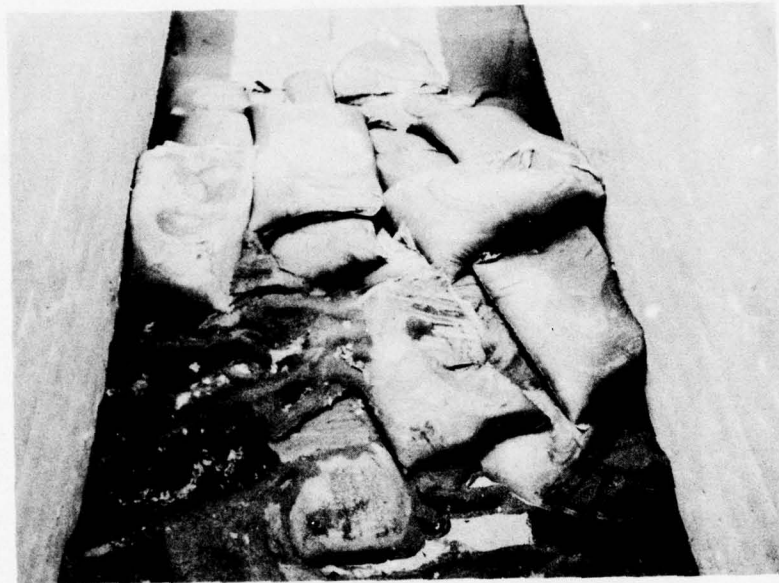
base of the structure during condition c was moved back during condition d, forming mounds at both toes of the structure (Figs. 17, 18, and 19) and flattening the front slope, but causing no change in crest elevation. Wave-induced changes in the structure were small compared to the disruption when the tank was drained.

Figure 17. Front face at end of test I.

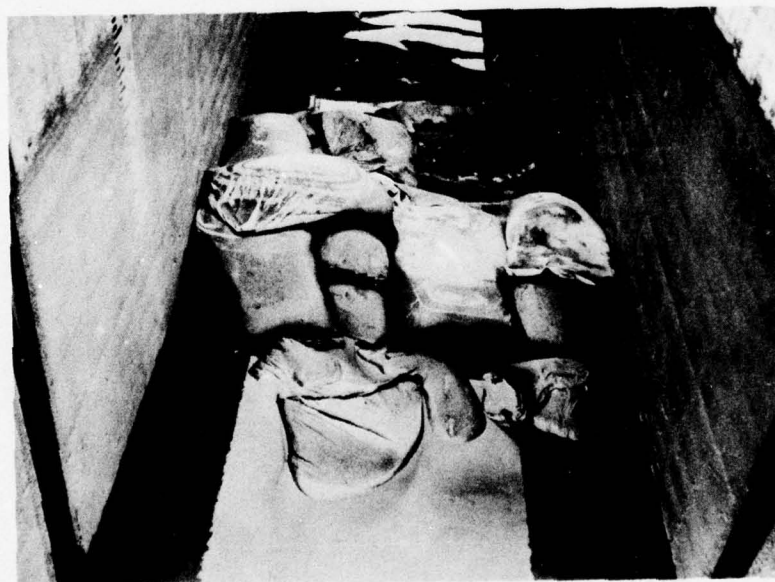
Figure 18. Backface at end of test I.

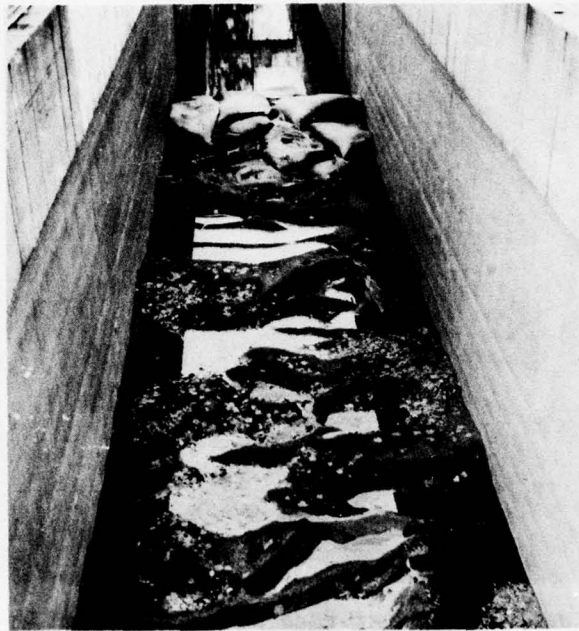
Figure 19. Sand bed to seaward at end of test I.

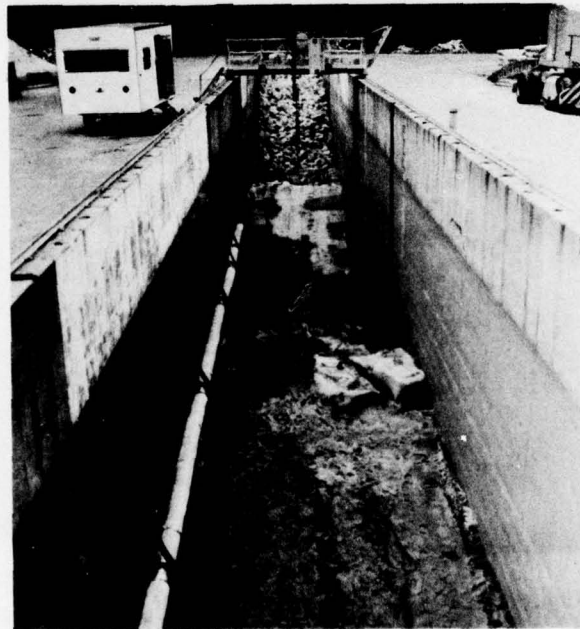
Figure 20. Relief pipe on sand bed and remains of structure I.

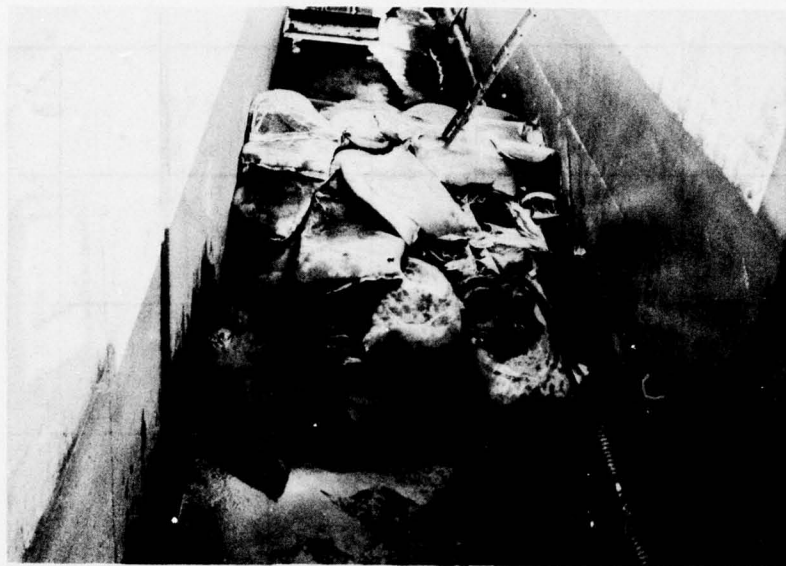
c. Structure Changes. During wave condition a the top layer of bags was displaced off the structure crest, the backface slumped and the front face settled, resulting in a decrease in crest elevation, an increase in crest width, and a flattening of both slopes despite scour at the rear toe (Fig. 24). Changes during wave condition b were negligible. Although more scour occurred at both toes during wave condition c, bags in the backface were displaced off the structure or, if damaged, stayed in place and leaked sand, flattening the back slope. The front face settled and bags from the crest were displaced onto it, flattening the front slope, widening the crest, and lowering the crest elevation. Wave condition d caused accretion of sand at the front toe, but the lower half of the front face settled, steepening the front slope slightly. No change in elevation occurred. After completion of test II, two torn and empty bags were discovered on the crest of the structure (Figs. 25 and 26) and large sand ripples were observed in the sand bed indicating active sand movement (Figs. 27 and 28).

Figure 25. Backface and damaged bags at end of test II.

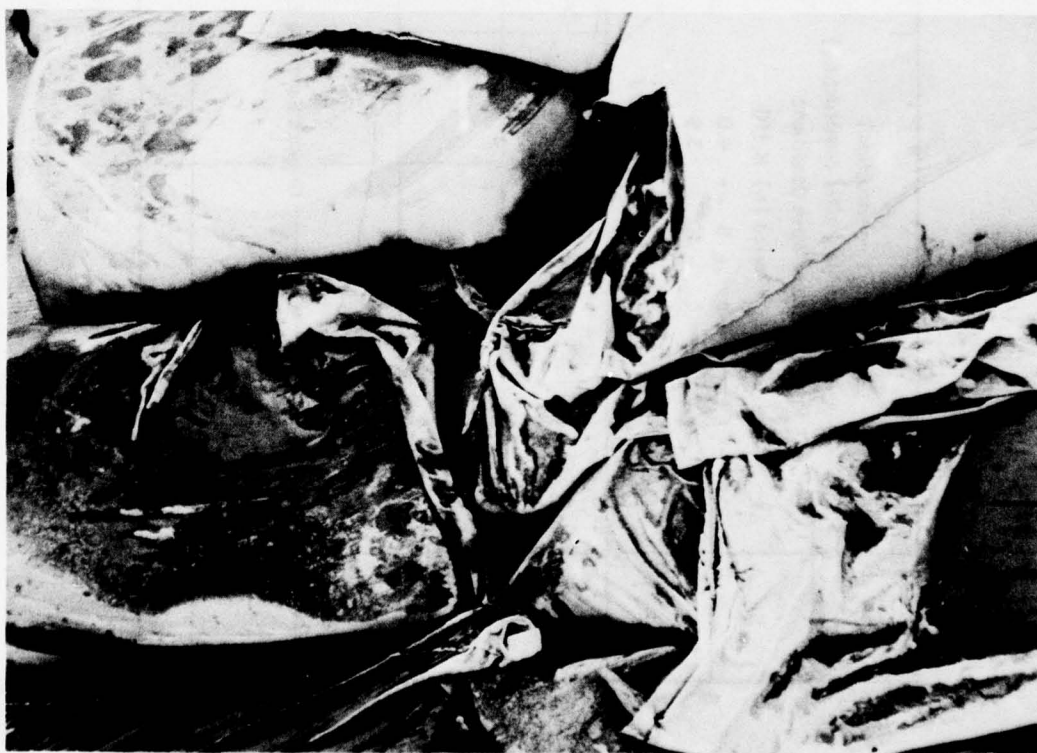
Figure 26. Damaged bags at end of test II.

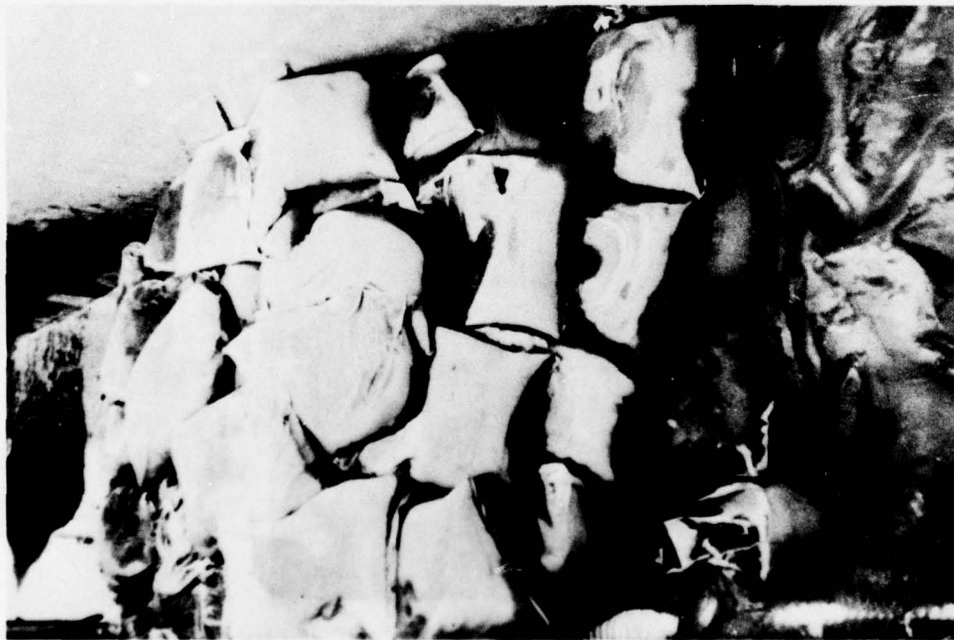
Figure 27. Front face at end of test II.

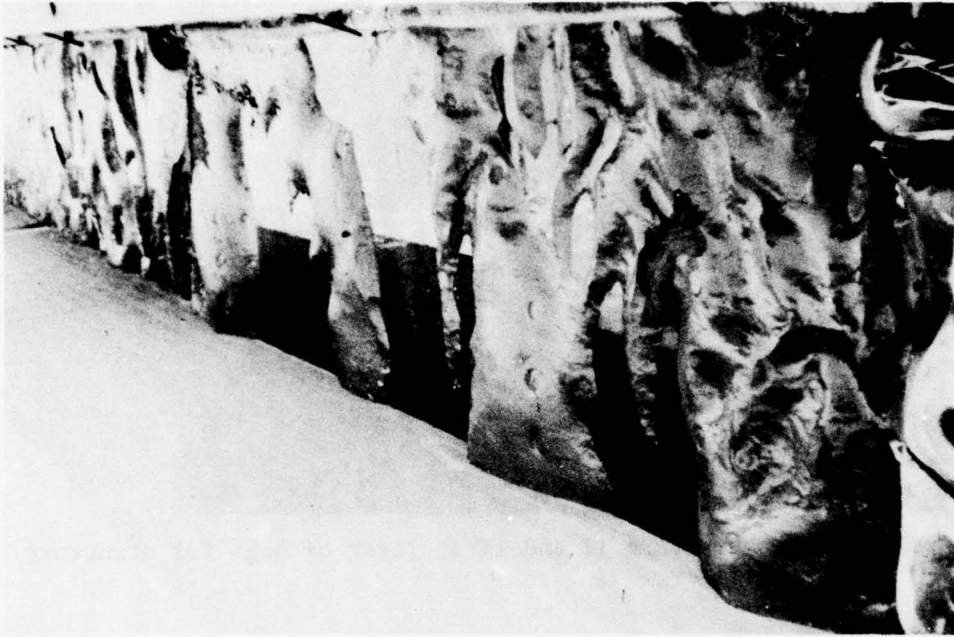
Figure 28. Sand bed to seaward at end of test II.

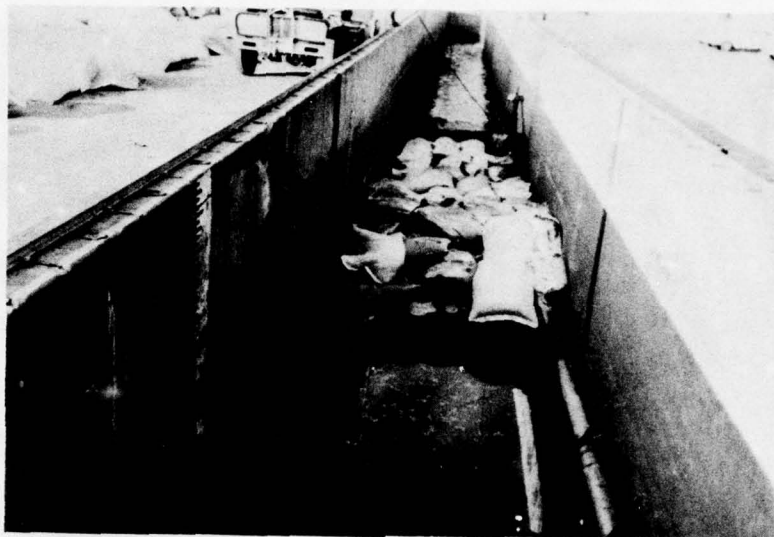
Figure 29. Repairs to structure II and first layer of bags for structure III (test III).

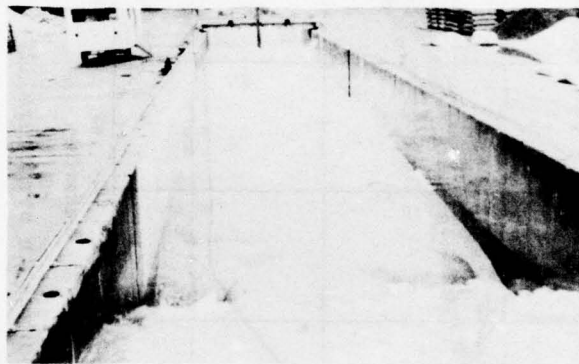
e. Structure Changes by "High" Waves. When wave condition c was run continuously, bag movement occurred over all of the visible crest and front face (Fig. 35) until setup behind the breakwater stabilized. When waves were run in bursts of 20 (Fig. 36), extensive movement of the bags continued until a new stabilized profile was attained after the top layer of bags was displaced onto the pile of bags on the backface and the bags on the upper part of the front face underwent small displacements. Wave condition c flattened the front slope and left the structure with a lower, wider crest. During wave condition d, the pile of bags on the backface slumped, decreasing the crest elevation, and bags on the front face continued to settle and undergo small displacements, flattening the slope slightly (Figs. 37, 38, and 39). Changes in the sand bed elevation at the back toe during test III were negligible; changes at the front toe were only about 50 percent as large as changes during tests I and II.

Figure 35. Breakwater crest under wave trough during wave condition c (test III).

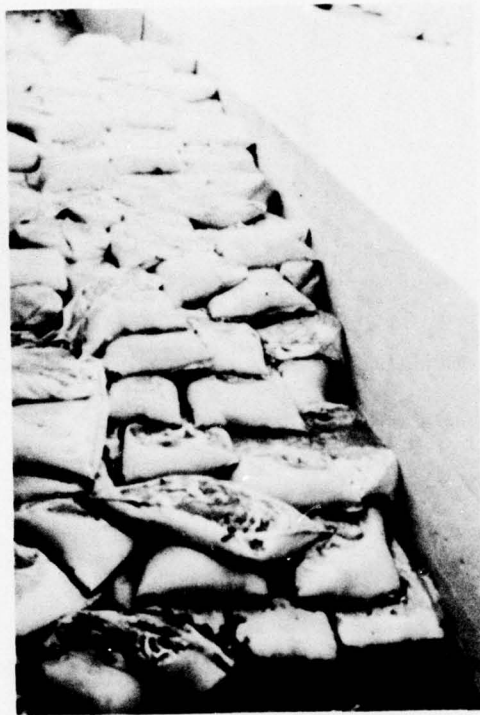
Figure 37. Front face at end of test III.

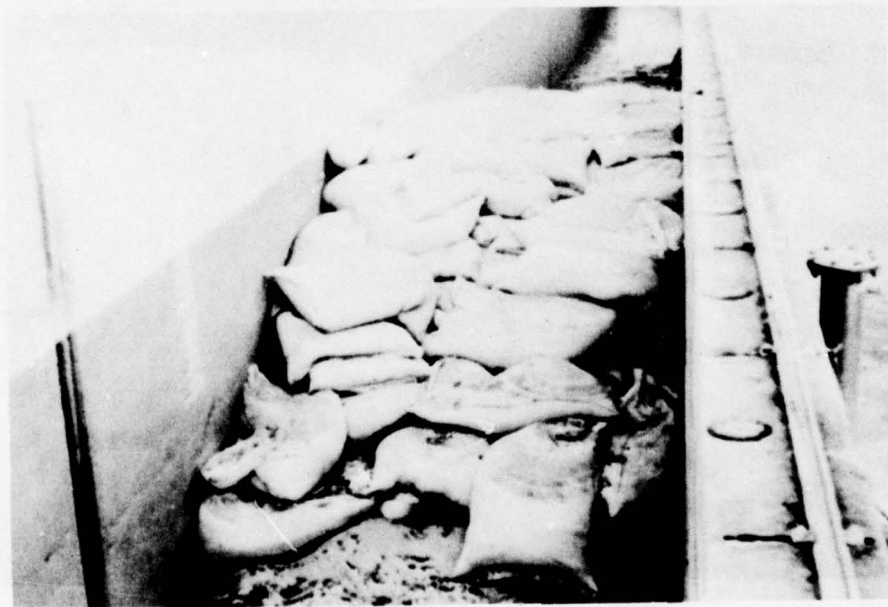
Figure 38. Backface at end of test III.

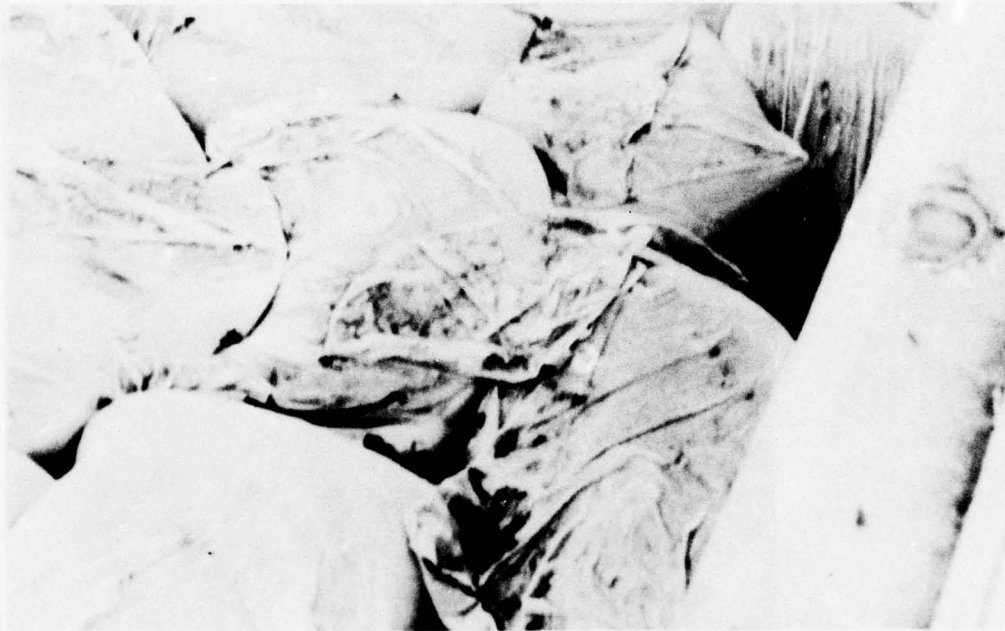
Figure 39. Damaged bags in front face at end of test III.

Both damaged and undamaged bags displayed forms of instability under wave action. Sand was "sucked out" of torn bags until the bags were nearly empty. Evidently, this loss of sand contributed to the settlement during tests I and II. Damaged bags were found in every structure, usually lying in the installed position, implying that the bags were torn during placement. Undamaged bags included even those bags that were displaced suddenly from the crests of the structures to the sand bed. Most changes in the structures were due to movement of undamaged bags. The nylon material was slippery and trapped air, which added buoyancy to the bags, formed cushioning bubbles on the tops and side, and prevented adequate interlocking despite the carefully overlapped layers.

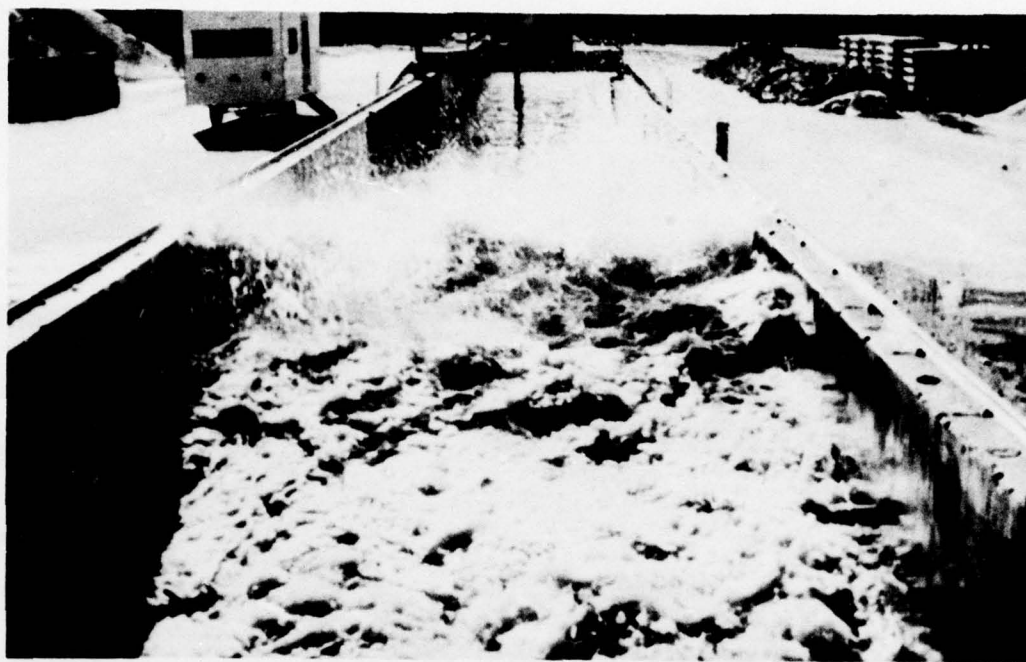
c. Structure Changes. During the first 60 waves of condition a, many bags were dislodged from the front face of structure IV, the damage starting in the third layer from the top and progressing upward to the top seaward row of bags (Fig. 45). As the wave condition was continued, the seaward row of bags in the upper part of the front face (i.e., from the crest to 3 feet below the stillwater level) slumped to the lower part of the face (Fig. 46), leaving the shoreward row on the crest almost untouched (Fig. 47). The front slope flattened dramatically and the crest lost 38 percent of its width but little of its height (Fig. 48). Wave condition b moved scattered bags on the front face downslope about 1 foot, but did not change the height or front slope significantly. During the first burst of waves of condition c, three bags from the remaining row on the crest were displaced onto the backface, decreasing the crest elevation. After the 60th wave, bags on the front face began moving with the wave action, slowly sliding down the face. After 440 waves, the whole upper half of the front face began slumping toward the toe and the bags remaining on the top of the structure began moving shoreward. All bags visible above water appeared to be moving. The slope of the upper half of the front face continued to flatten as the crest elevation continued to decrease. Wave

Figure 43. Wave breaking on front face after loss of seaward row of bags on breakwater crest during wave condition a (test IV).

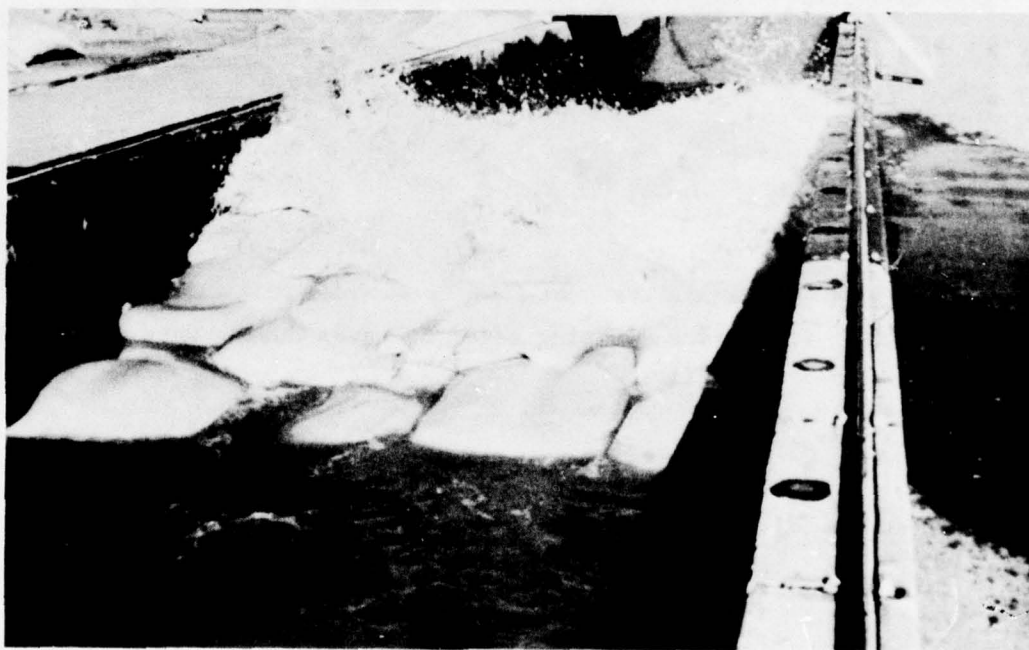
Figure 44. Breaking wave overtopping after loss of seaward row of bags on breakwater crest during wave condition a (test IV).

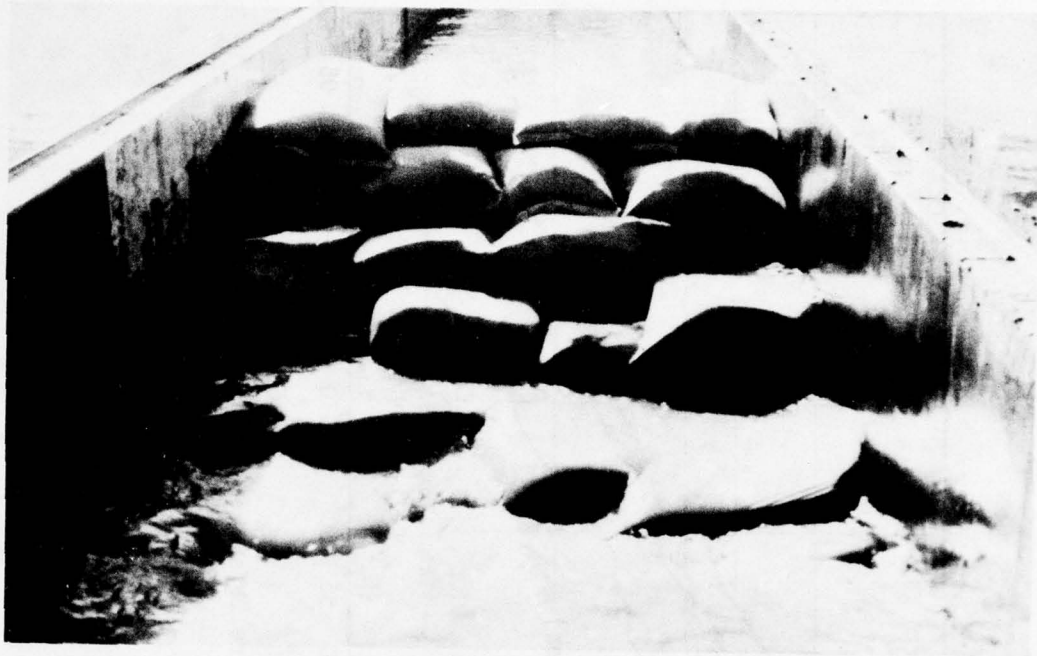
Figure 46. Front face after 50 waves shows seaward row of bags missing from breakwater crest during wave condition a (test IV).

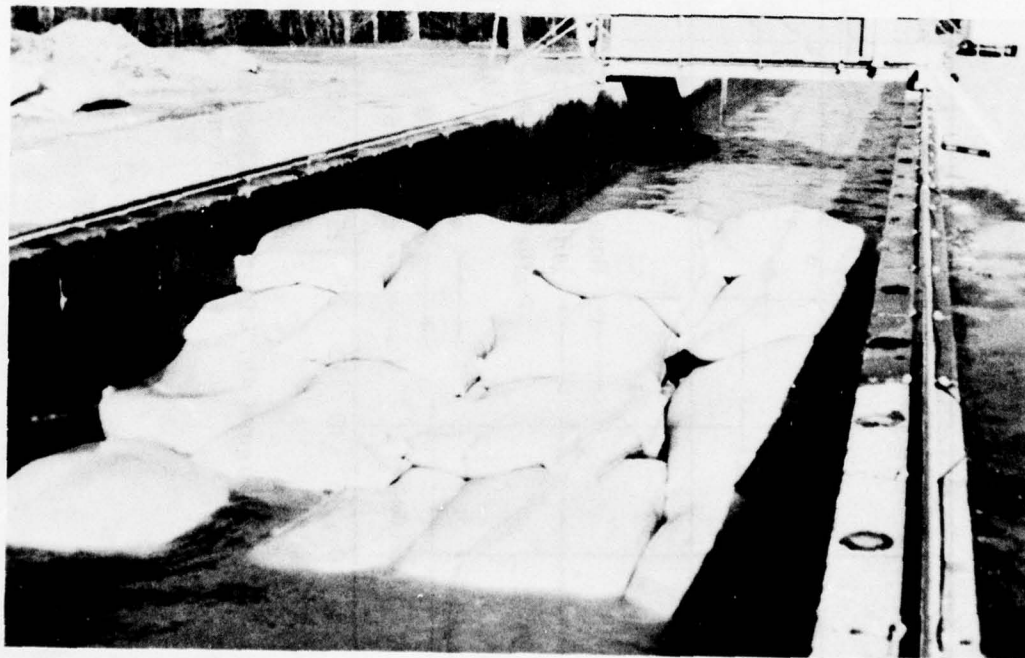
Figure 47. Backface after 50 waves shows shoreward row of bags across crest intact during wave condition a (test IV).

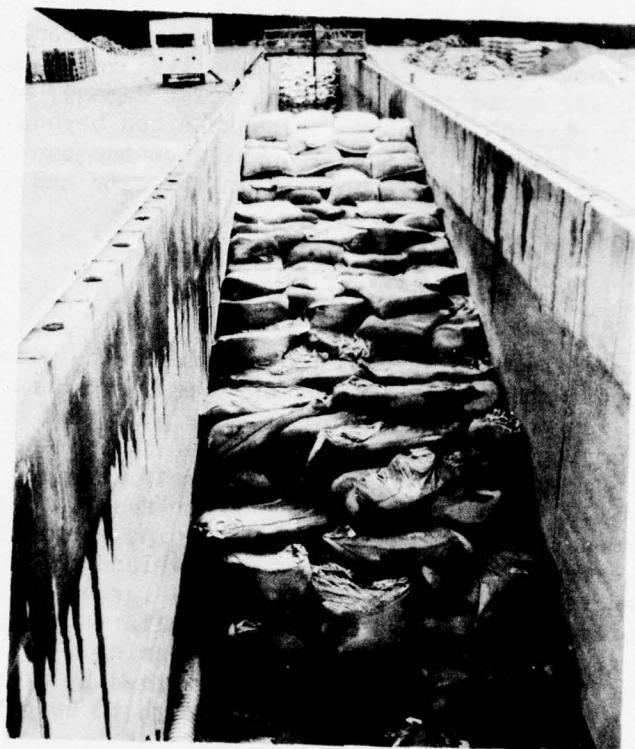
condition c was terminated when all visible movement stopped (Figs. 49 and 50). As experience during tests I, II, and III had shown that wave conditions a and c produced the most significant damage, structure IV was not subjected to wave condition d. The sand bed beyond the toes of the structure was not surveyed in test IV, but when the tank was drained at the end of the test, only slight changes in the sand bed were observed.

Figure 49. Front face at end of test IV.

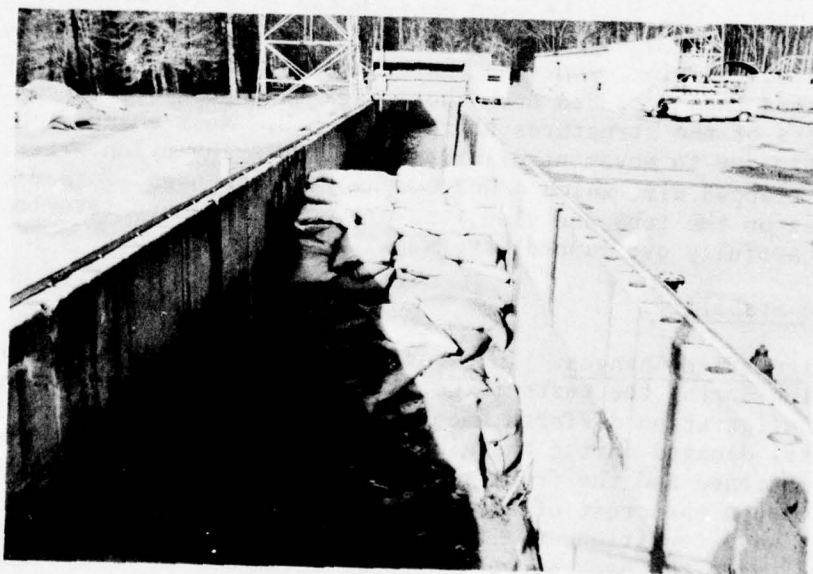
Figure 50. Backface at end of test IV.
